**Flood Control Project Maintenance
Levee Inspections**
LMA District Cover Sheet
Spring 2016 Levee Inspection Results

American River Flood Control District

Spring 2016 Levee Inspection Results

Waterway			Bank	Unit Miles
Unit No. 01 Arcade Creek			Left	2.08
	Spring (March - May)	Summer (June - August)	(September - November) Fall	Winter (December - February)
Unit Maintenance Rating (Fall Only)				
Date of Inspection	3/2/2016 - 3/2/2016			
DWR Inspector	Maksim Khashchuk			
Accompanied By	Richard Marck ARFCD			
	Sterling York

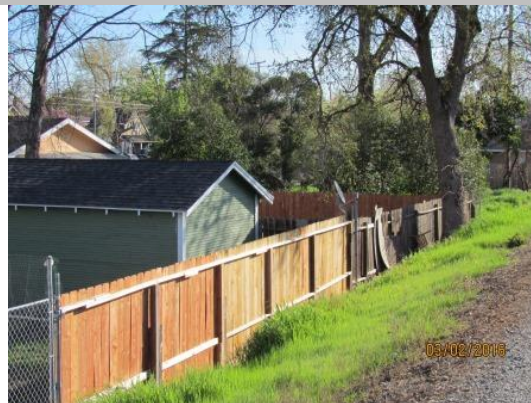
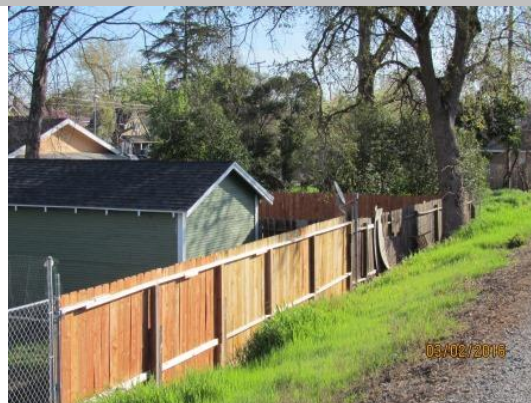
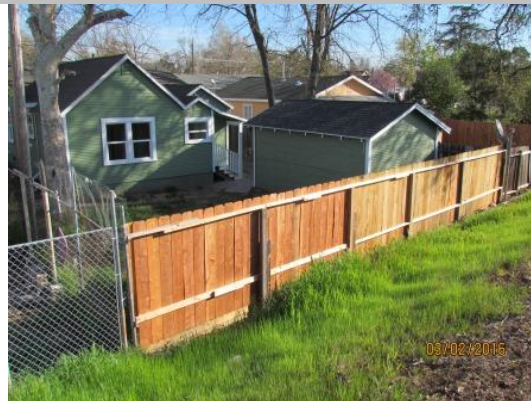
LM Start	1.57	Rating **	U	Issue No.	3 (cont)	
LM End	1.57	Issue Type +	En	Location *	LS	
Category	Earthen Levee			GPS Latitude/Longitude		
				Start		End
Item	Encroachments			38.627768 °		38.627768 °
				-121.442185 °		-121.442185 °
DWR ID	DWR_NA0001_07_s_2012_3					
Comment Code						
FE : Fence						
Inspector Comment						
Wooden privacy fence is within 10-ft of the levee toe.

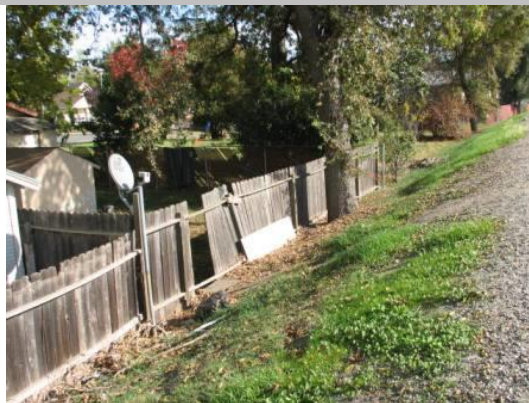
Photo 1 of 1 : SP_2016_NA0001_58_4_20160229_00003.jpg

LM Start	1.58	Rating **	U	Issue No.	4
LM End	1.58	Issue Type +	En	Location *	LS
Category	Earthen Levee			GPS Latitude/Longitude	
				Start	End
Item	Encroachments			38.627707 °	38.627707 °
				-121.441965 °	-121.441965 °
DWR ID	DWR_NA0001_07_s_2012_4				
Comment Code					
FE : Fence					
Inspector Comment					
Wooden privacy fence is within 10-ft of the levee toe.

11/17/2011 Wooden privacy fence is constructed at the toe.

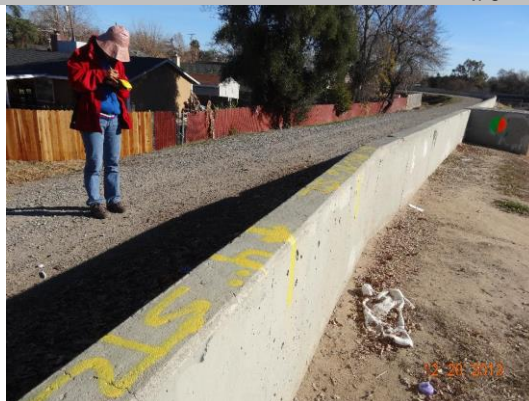
Photo 2 of 2 : UCIP_SP_2016_46795_57525.jpg

LM Start	1.60	Rating **	M	Issue No.	49 (cont)
LM End	1.60	Issue Type +	En	Location *	LS
Category	Supplemental			GPS Latitude/Longitude	
				Start	End
Item	DWR UCIP Field Study			38.627760 °	38.627760 °
				-121.441593 °	-121.441593 °
DWR ID					
Comment Code					
Inspector Comment					
FS_ID:46795					
DS_ID:24835					
EP_NO: N/A					
Repair Type: Non-Urgent					
Crossing Status: Indicator Found					
UCIP Comments: 11/12/15 Markers have been installed on both levees--confirmed during 2015 DWR Fall Inspection. Need to coordinate with PG&E to determine permit for this crossing.12/19/13					
Gas line - no markers visible. No permit available.					
FIELD_STRUCT_DESC: 2 of 2: 6-inch pipe through the levee and under the channel at an unknown depth.					
FS Date: 12/20/2013

Underground service alert (USA) markings visible on floodwall.

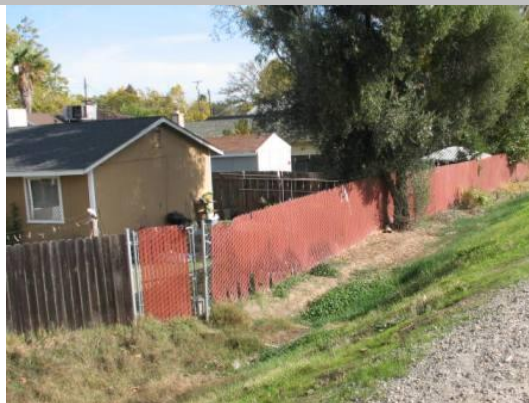
Photo 1 of 1 : SP_2016_NA0001_58_29_20160229_00025.jpg

LM Start	1.61	Rating **	M	Issue No.	29
LM End	1.61	Issue Type +	En	Location *	LS
Category	Earthen Levee			GPS Latitude/Longitude	
				Start	End
Item	Encroachments			38.627733 °	38.627733 °
				-121.441415 °	-121.441415 °
DWR ID	DWR_NA0001_07_s_2012_29				
Comment Code					
FE : Fence					
Inspector Comment					
Privacy fence is within 10-ft of the levee toe.

11/17/2011 Privacy fence is constructed at the toe.

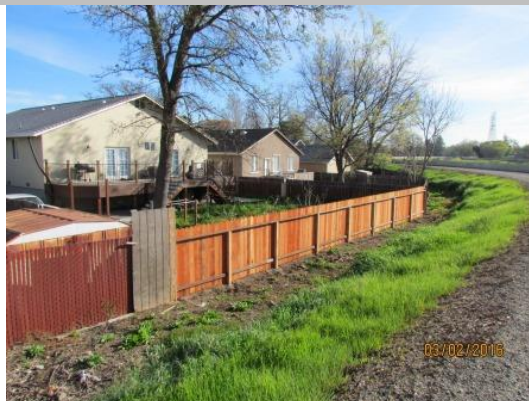
Photo 1 of 1 : SP_2016_NA0001_58_26_20160308_00052.jpg

LM Start	1.64	Rating **	U	Issue No.	26
LM End	1.64	Issue Type +	En	Location *	LS
Category	Earthen Levee			GPS Latitude/Longitude	
				Start	End
Item	Encroachments			38.627667 °	38.627667 °
				-121.440837 °	-121.440837 °
DWR ID	DWR_NA0001_07_s _ 2012_26				
Comment Code					
FE : Fence					
Inspector Comment					
Wooden privacy fence is within 10-ft of the levee toe.

View of the wooden fence at the landside levee toe.

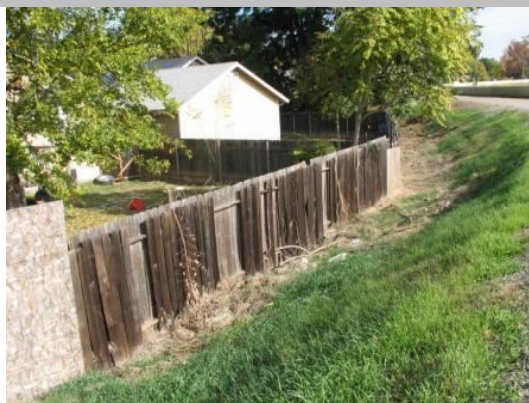
Photo 1 of 1 : SP_2016_NA0001_58_25_20160229_00021.jpg

LM Start	1.65	Rating **	U	Issue No.	25
LM End	1.65	Issue Type +	En	Location *	LS
Category	Earthen Levee			GPS Latitude/Longitude	
				Start	End
Item	Encroachments			38.627677 °	38.627677 °
				-121.440629 °	-121.440629 °
DWR ID	DWR_NA0001_07_s _ 2012_25				
Comment Code					
FE : Fence					
Inspector Comment					
Wooden privacy fence is within 10-ft of the levee toe.

11/17/2011 Wooden privacy fence is constructed at the toe.

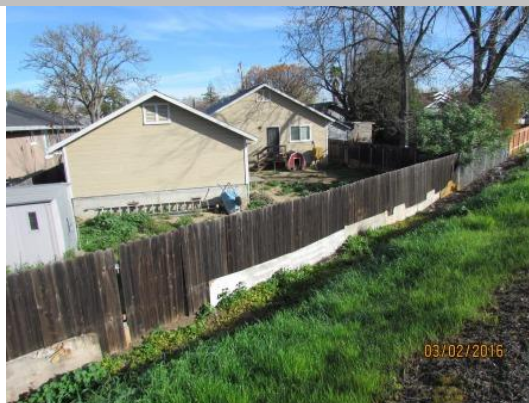
Photo 1 of 1 : SP_2016_NA0001_58_40_20160308_00053.jpg

LM Start	1.66	Rating **	U	Issue No.	40
LM End	1.66	Issue Type +	En	Location *	LS
Category	Earthen Levee			GPS Latitude/Longitude	
				Start	End
Item	Encroachments			38.627727 °	38.627727 °
				-121.440442 °	-121.440442 °
DWR ID	DWR_NA0001_07_s _ 2016_40				
Comment Code					
FE : Fence					
Inspector Comment

View of the fence at the landside levee toe.

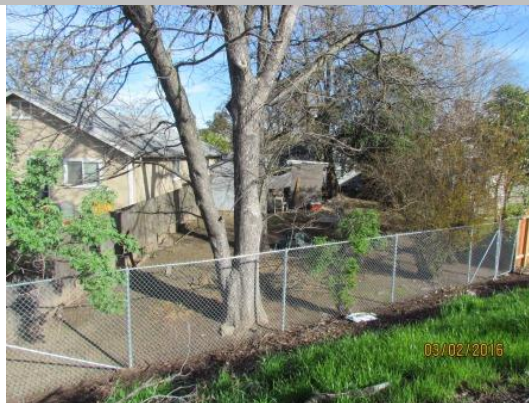
Photo 1 of 1 : SP_2016_NA0001_58_41_20160308_00054.jpg

LM Start	1.67	Rating **	M	Issue No.	41
LM End	1.67	Issue Type +	En	Location *	LS
Category	Earthen Levee			GPS Latitude/Longitude	
				Start	End
Item	Encroachments			38.627803 °	38.627803 °
				-121.440270 °	-121.440270 °
DWR ID	DWR_NA0001_07_s _ 2016_41				
Comment Code					
FE : Fence					
Inspector Comment

View of the fence at the landside levee toe.

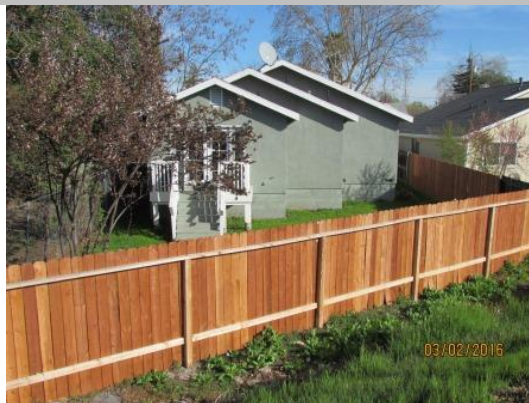
Photo 1 of 1 : SP_2016_NA0001_58_44_20160308_00055.jpg

LM Start	1.68	Rating **	U	Issue No.	44
LM End	1.68	Issue Type +	En	Location *	LS
Category	Earthen Levee			GPS Latitude/Longitude	
				Start	End
Item	Encroachments			38.627874 °	38.627874 °
				-121.440134 °	-121.440134 °
DWR ID	DWR_NA0001_07_s _ 2016_44				
Comment Code					
FE : Fence					
Inspector Comment

View of the fence at the landside levee toe.

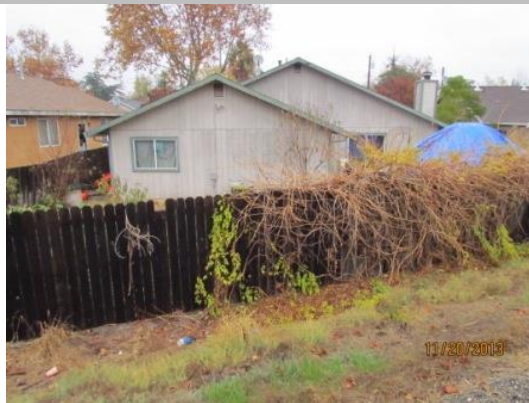
Photo 1 of 1 : SP_2016_NA0001_58_6_20160229_00004.jpg

LM Start	1.69	Rating **	U	Issue No.	6
LM End	1.69	Issue Type +	En	Location *	LS
Category	Earthen Levee			GPS Latitude/Longitude	
				Start	End
Item	Encroachments			38.627948 °	38.627948 °
				-121.439958 °	-121.439958 °
DWR ID	DWR_NA0001_07_s _ 2012_6				
Comment Code					
FE : Fence					
Inspector Comment					
Wooden privacy fence with vines are within 10-ft of the levee toe.

View of the wooden fence at the landside levee toe.

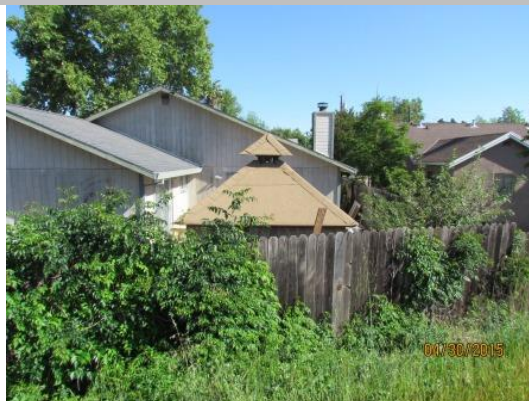
Photo 1 of 1 : SP_2016_NA0001_58_1_20160229_00001.jpg

LM Start	1.69	Rating **	U	Issue No.	1
LM End	1.69	Issue Type +	En	Location *	LS
Category	Earthen Levee			GPS Latitude/Longitude	
				Start	End
Item	Encroachments			38.627956 °	38.627956 °
				-121.439962 °	-121.439962 °
DWR ID	DWR_NA0001_07_s _ 2012_1				
Comment Code					
BU : Building					
Inspector Comment					
Construction of new structure is witin 15' of levee.

View of the shed at the landside levee toe.

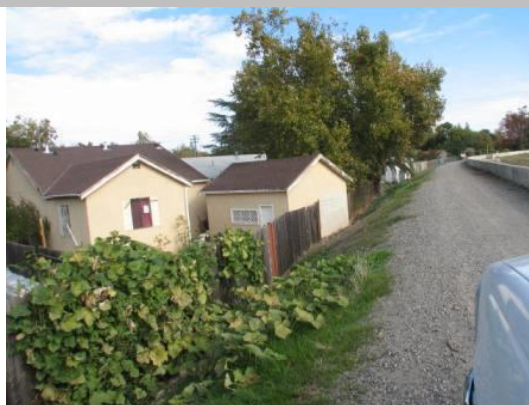
Photo 1 of 1 : SP_2016_NA0001_58_7_20160229_00005.jpg

LM Start	1.70	Rating **	U	Issue No.	7
LM End	1.70	Issue Type +	En	Location *	LS
Category	Earthen Levee			GPS Latitude/Longitude	
				Start	End
Item	Encroachments			38.627935 °	38.627935 °
				-121.439758 °	-121.439758 °
DWR ID	DWR_NA0001_07_s _ 2012_7				
Comment Code					
BU : Building					
Inspector Comment					
Corner of building protrudes into levee slope. Wooden fence is built on the levee slope.

11/17/2011 Building is constructed at the toe.

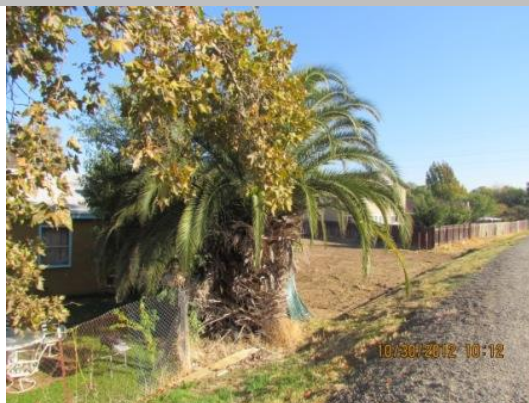
Photo 1 of 1 : SP_2016_NA0001_58_24_20160229_00020.jpg

LM Start	1.72	Rating **	M	Issue No.	24
LM End	1.72	Issue Type +	En	Location *	LS
Category	Earthen Levee			GPS Latitude/Longitude	
				Start	End
Item	Vegetation			38.628086 °	38.628086 °
				-121.439544 °	-121.439544 °
DWR ID	DWR_NA0001_07_s _ 2012_24				
Comment Code					
V6 : Landscaping					
Inspector Comment					
Palm tree was trimmed up.

View of palm tree within 10-ft of the levee toe trimmed up from previous inspection.

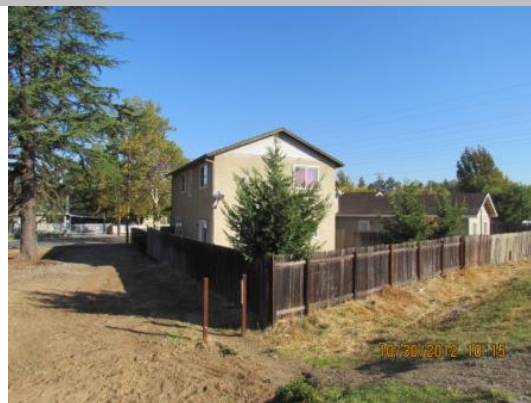
Photo 1 of 1 : SP_2016_NA0001_58_23_20160229_00019.jpg

LM Start	1.74	Rating **	U	Issue No.	23
LM End	1.74	Issue Type +	En	Location *	LS
Category	Earthen Levee			GPS Latitude/Longitude	
				Start	End
Item	Encroachments			38.628221 °	38.628221 °
				-121.439138 °	-121.439138 °
DWR ID	DWR_NA0001_07_s_2012_23				
Comment Code					
FE : Fence					
Inspector Comment					
Wooden fence and cedar trees are within 10-ft of levee toe.

View of wooden privacy fence constructed at the toe.

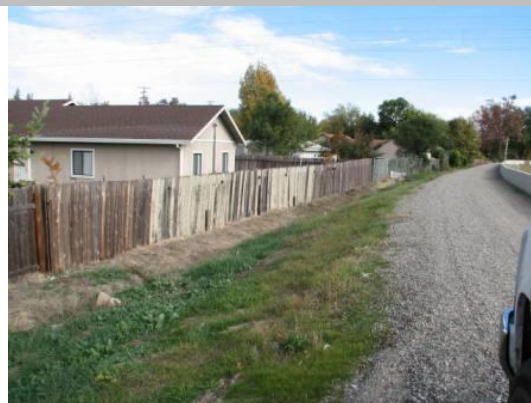
Photo 1 of 1 : SP_2016_NA0001_58_9_20160229_00007.jpg

LM Start	1.75	Rating **	U	Issue No.	9
LM End	1.75	Issue Type +	En	Location *	LS
Category	Earthen Levee			GPS Latitude/Longitude	
				Start	End
Item	Encroachments			38.628197 °	38.628197 °
				-121.438863 °	-121.438863 °
DWR ID	DWR_NA0001_07_s_2012_9				
Comment Code					
FE : Fence					
Inspector Comment					
Wooden privacy fence is within 10-ft of the levee toe.

11/17/2011 Wooden privacy fence is constructed at the toe.

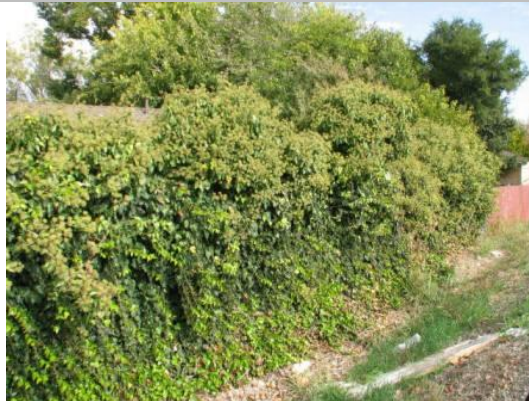
Photo 1 of 1 : SP_2016_NA0001_58_11_20160229_00009.jpg

LM Start	1.80	Rating **	U	Issue No.	11
LM End	1.80	Issue Type +	En	Location *	LS
Category	Earthen Levee			GPS Latitude/Longitude	
				Start	End
Item	Vegetation			38.628297 °	38.628297 °
				-121.437995 °	-121.437995 °
DWR ID	DWR_NA0001_07_f_2012_11				
Comment Code					
V6 : Landscaping					
Inspector Comment					
Dense ivy and landscaping planted on chain link fence on levee toe. Porch and awning are within 10-ft of the levee toe.

11/17/2011 Overgrown vegetation obstructs visibility and access.

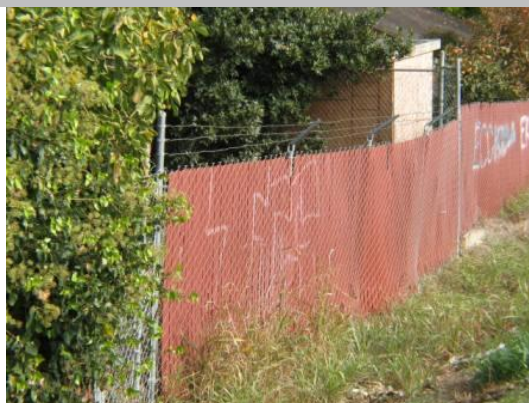
Photo 1 of 1 : SP_2016_NA0001_58_12_20160229_00010.jpg

LM Start	1.81	Rating **	U	Issue No.	12
LM End	1.81	Issue Type +	En	Location *	LS
Category	Earthen Levee			GPS Latitude/Longitude	
				Start	End
Item	Encroachments			38.628307 °	38.628307 °
				-121.437842 °	-121.437842 °
DWR ID	DWR_NA0001_07_s_2012_12				
Comment Code					
FE : Fence					
Inspector Comment					
Chain link privacy fence with barbed wire is within 10-ft of levee toe.

11/17/2011 Barbed wire topped privacy fence is located at the toe.

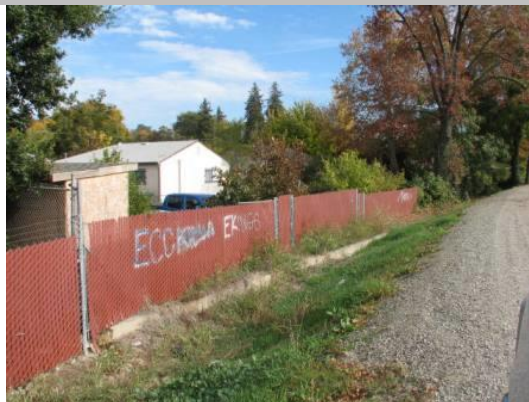
Photo 1 of 1 : SP_2016_NA0001_58_13_20160229_00011.jpg

LM Start	1.82	Rating **	U	Issue No.	13
LM End	1.82	Issue Type +	En	Location *	LS
Category	Earthen Levee			GPS Latitude/Longitude	
				Start	End
Item	Encroachments			38.628303 °	38.628303 °
				-121.437693 °	-121.437693 °
DWR ID	DWR_NA0001_07_s_2012_13				
Comment Code					
FE : Fence					
Inspector Comment					
Chain link privacy fence is within 10-ft of levee toe.

11/17/2011 Privacy fence is located at the toe.

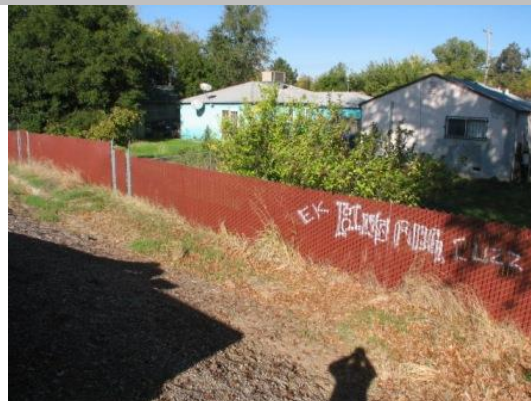
Photo 1 of 1 : SP_2016_NA0001_58_14_20160229_00012.jpg

LM Start	1.83	Rating **	U	Issue No.	14
LM End	1.83	Issue Type +	En	Location *	LS
Category	Earthen Levee			GPS Latitude/Longitude	
				Start	End
Item	Encroachments			38.628303 °	38.628303 °
				-121.437530 °	-121.437530 °
DWR ID	DWR_NA0001_07_s_2012_14				
Comment Code					
FE : Fence					
Inspector Comment					
Chain link privacy fence is within 10-ft of levee toe.

Fall 2009 photo of privacy fence within 10-ft of the levee toe obstructs visibility and access.

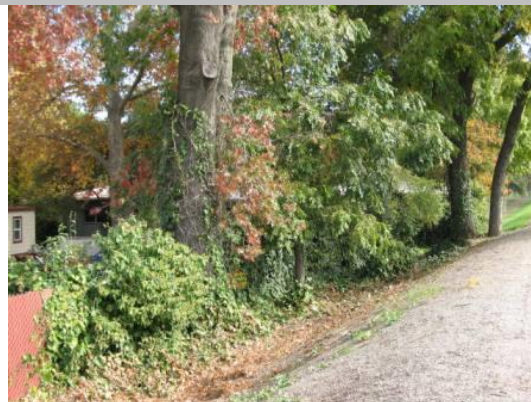
Photo 1 of 2 : SP_2016_NA0001_58_15_20160229_00013.jpg

LM Start	1.84	Rating **	U	Issue No.	15
LM End	1.84	Issue Type +	En	Location *	LS
Category	Earthen Levee			GPS Latitude/Longitude	
				Start	End
Item	Vegetation			38.628295 °	38.628295 °
				-121.437282 °	-121.437282 °
DWR ID	DWR_NA0001_07_s_2012_15				
Comment Code					
V6 : Landscaping					
Inspector Comment					
Dense ivy growing on chain link fence within 10-ft of levee toe.

11/17/2011 Dense vegetation at the toe.

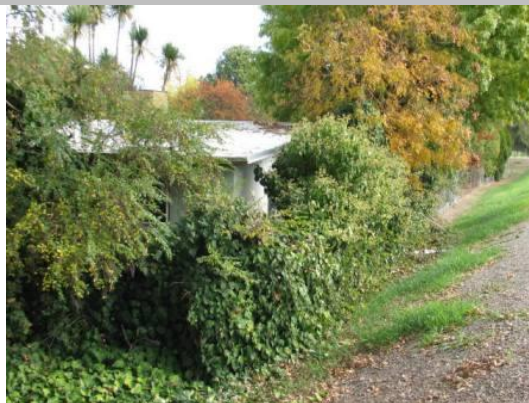
Photo 1 of 1 : SP_2016_NA0001_58_16_20160229_00015.jpg

LM Start	1.86	Rating **	U	Issue No.	16
LM End	1.86	Issue Type +	En	Location *	LS
Category	Earthen Levee			GPS Latitude/Longitude	
				Start	End
Item	Vegetation			38.628262 °	38.628262 °
				-121.436985 °	-121.436985 °
DWR ID	DWR_NA0001_07_s _ 2012_16				
Comment Code					
V6 : Landscaping					
Inspector Comment					
Dense ivy and trees along chain link fence on levee toe. Large building is within 10-ft of levee toe.

11/17/2011 Vegetation and building obstruct visibility and access to the levee toe.

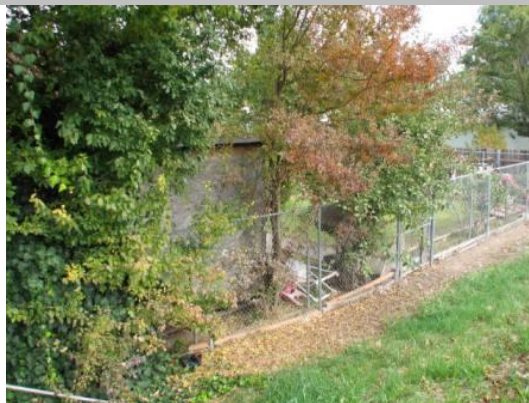
Photo 1 of 1 : SP_2016_NA0001_58_22_20160229_00018.jpg

LM Start	1.87	Rating **	U	Issue No.	22
LM End	1.87	Issue Type +	En	Location *	LS
Category	Earthen Levee			GPS Latitude/Longitude	
				Start	End
Item	Encroachments			38.628318 °	38.628318 °
				-121.436794 °	-121.436794 °
DWR ID	DWR_NA0001_07_s _ 2012_22				
Comment Code					
BU : Building					
Inspector Comment					
Wooden shed and landscaping along chain link fence within 10-ft of levee toe.

11/17/2011 Building is too close to the levee toe and obstructs visibility and access.

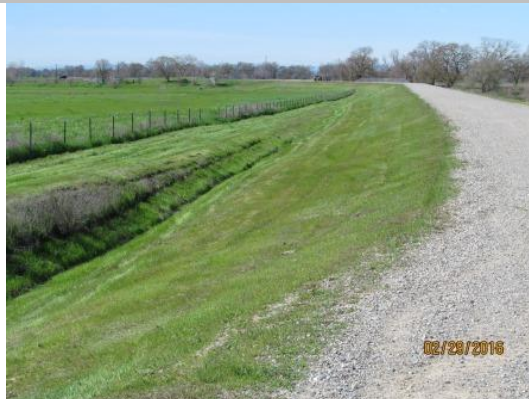
Photo 1 of 1 : SP_2016_NA0001_59_16_20160307_00016.jpg

LM Start	0.27	Rating **	A	Issue No.	16	
LM End	0.27	Issue Type +	Ma	Location *	LS	
Category	Earthen Levee			GPS Latitude/Longitude		
				Start		End
Item	Vegetation			38.668222 °		38.668222 °
				-121.442510 °		-121.442510 °
DWR ID	DWR_NA0001_08_s _ 2016_16					
Comment Code						
V1 : Control annual grass and weeds on the levee slopes and easements.						
Inspector Comment

View of the vegetation on the landside levee slope, looking downstream.

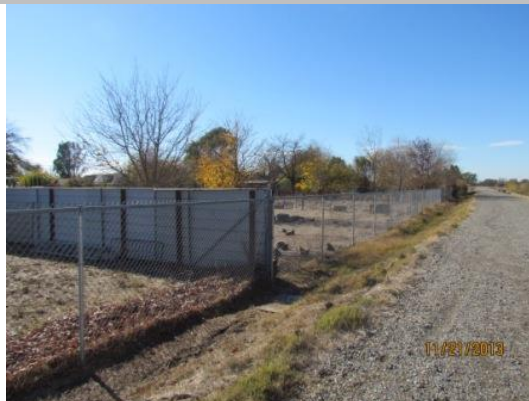
Photo 1 of 1 : SP_2016_NA0001_59_4_20160229_00003.jpg

LM Start	0.30	Rating **	M	Issue No.	4
LM End	0.49	Issue Type +	En	Location *	LS
Category	Earthen Levee			GPS Latitude/Longitude	
				Start	End
Item	Encroachments			38.668191 °	38.668118 °
				-121.442059 °	-121.438659 °
DWR ID	DWR_NA0001_08_s _ 2012_4				
Comment Code					
FE : Fence					
Inspector Comment					
Chain link fence near levee toe limits access.

View of the chainlink fence at landside levee toe facing downstream.

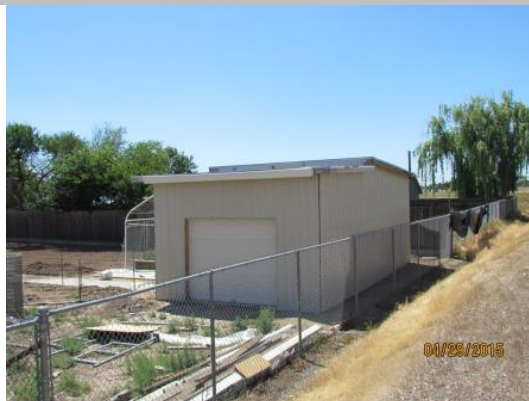
Photo 1 of 1 : SP_2016_NA0001_59_15_20160229_00007.jpg

LM Start	0.33	Rating **	U	Issue No.	15
LM End	0.33	Issue Type +	En	Location *	LS
Category	Earthen Levee			GPS Latitude/Longitude	
				Start	End
Item	Encroachments			38.668135 °	38.668135 °
				-121.441563 °	-121.441563 °
DWR ID	DWR_NA0001_08_f_2013_15				
Comment Code					
BU : Building					
Inspector Comment					
Building within 10 feet of landside levee toe.

View of the building within 10 feet of landside levee toe, facing downstream.

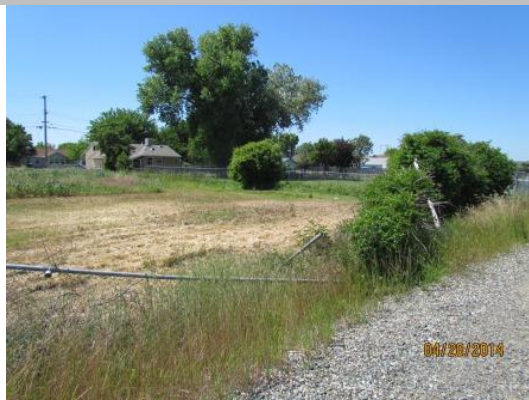
Photo 1 of 1 : SP_2016_NA0001_59_22_20160229_00009.jpg

LM Start	0.39	Rating **	M	Issue No.	22
LM End	0.39	Issue Type +	En	Location *	LS
Category	Earthen Levee			GPS Latitude/Longitude	
				Start	End
Item	Encroachments			38.668155 °	38.668155 °
				-121.440484 °	-121.440484 °
DWR ID	DWR_NA0001_08_s_2014_22				
Comment Code					
FE : Fence					
Inspector Comment					
Remove fence from landside levee slope.

View of the broken fence on landside levee toe.

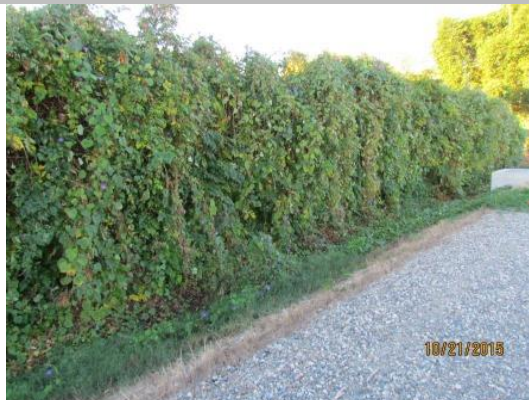
Photo 1 of 1 : SP_2016_NA0001_59_6_20160229_00004.jpg

LM Start	0.40	Rating **	U	Issue No.	6
LM End	0.43	Issue Type +	En	Location *	LS
Category	Earthen Levee			GPS Latitude/Longitude	
				Start	End
Item	Vegetation			38.668147 °	38.668141 °
				-121.440248 °	-121.439755 °
DWR ID	DWR_NA0001_08_s_2012_6				
Comment Code					
V6 : Landscaping					
Inspector Comment					
Vines on fence limit visibility.

View of the vines on fence obstructing visibility of landside toe.

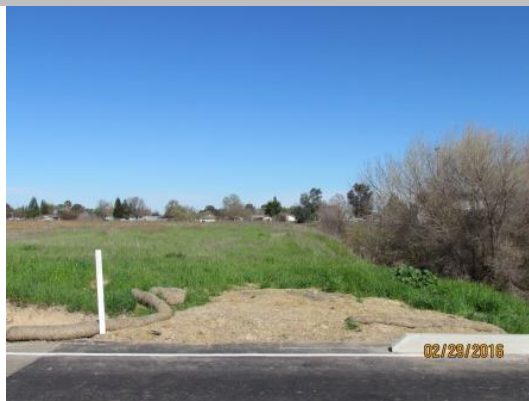
Photo 1 of 1 : SP_2016_NA0001_59_1_20160307_00017.jpg

LM Start	0.51	Rating **	U	Issue No.	1
LM End	1.03	Issue Type +	En	Location *	WS
Category	Earthen Levee			GPS Latitude/Longitude	
				Start	End
Item	Encroachments			38.668132 °	38.665528 °
				-121.438229 °	-121.431688 °
DWR ID	DWR_NA0001_08_s_2012_1				
Comment Code					
MA : Material					
Inspector Comment					
This portion of the levee is inaccessible for maintenance.

View from downstream end of inaccessible portion of Magpie Creek due to landowner restrictions. There is no levee for ARFCD to maintain at this location. However, the channel maintenance is the responsibility of Sacramento Yard, State DWR.

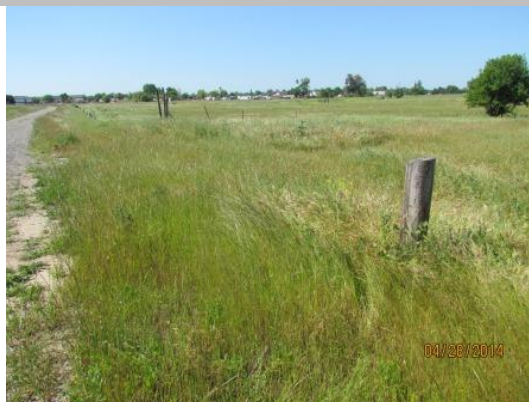
Photo 1 of 1 : SP_2016_NA0001_59_20_20160229_00008.jpg

LM Start	1.21	Rating **	M	Issue No.	20
LM End	1.21	Issue Type +	En	Location *	LS
Category	Earthen Levee			GPS Latitude/Longitude	
				Start	End
Item	Encroachments			38.662860 °	38.662860 °
				-121.431671 °	-121.431671 °
DWR ID	DWR_NA0001_08_s_2014_20				
Comment Code					
PO : Pole					
Inspector Comment

View of the pole on landside levee toe.

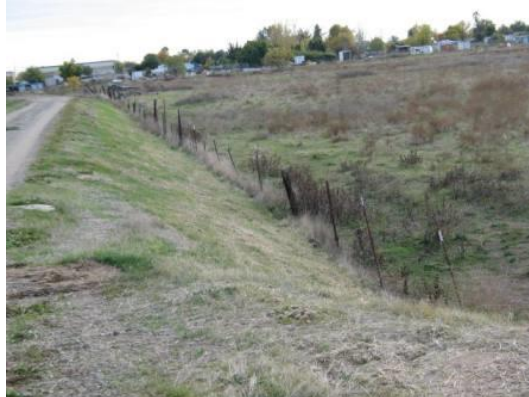
Photo 1 of 1 : SP_2016_NA0001_59_2_20160229_00002.jpg

LM Start	1.22	Rating **	M	Issue No.	2
LM End	1.31	Issue Type +	En	Location *	LS
Category	Earthen Levee			GPS Latitude/Longitude	
				Start	End
Item	Encroachments			38.662715 °	38.661584 °
				-121.431666 °	-121.431402 °
DWR ID	DWR_NA0001_08_s_2012_2				
Comment Code					
FE : Fence					
Inspector Comment					
Barbed wire fence runs along the levee toe.

11/17/2011 Barbed wire fence at levee toe.

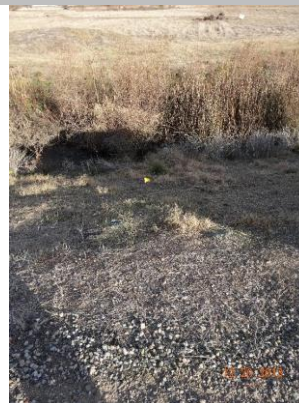
Photo 1 of 2 : UCIP_SP_2016_30689_56509.jpg

LM Start	1.28	Rating **	M	Issue No.	24
LM End	1.28	Issue Type +	En	Location *	LS
Category	Supplemental			GPS Latitude/Longitude	
				Start	End
Item	DWR UCIP Field Study			38.661843 °	38.661843 °
				-121.431675 °	-121.431675 °
DWR ID					
Comment Code					
Inspector Comment					
FS_ID:30689 DS_ID:24815 EP_NO: N/A Repair Type: Non-Urgent Crossing Status: Indicator Found UCIP Comments: unable to confirm if conduit or gas line cross levee or flag identifying problem areas. Need additional information. FIELD_STRUCT_DESC: Underground service alert (USA) markers found on waterside (WS) and landside (LS) during field inspection. FS Date: 12/20/2013

View of waterward side.

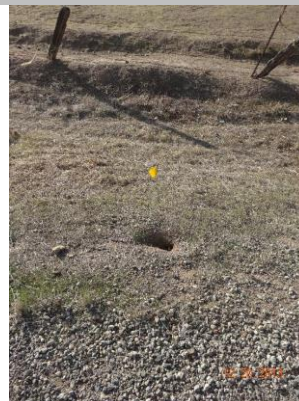
Photo 2 of 2 : UCIP_SP_2016_30689_56508.jpg

LM Start	1.28	Rating **	M	Issue No.	24 (cont)
LM End	1.28	Issue Type +	En	Location *	LS
Category	Supplemental			GPS Latitude/Longitude	
				Start	End
Item	DWR UCIP Field Study			38.661843 °	38.661843 °
				-121.431675 °	-121.431675 °
DWR ID					
Comment Code					
Inspector Comment					
FS_ID:30689 DS_ID:24815 EP_NO: N/A Repair Type: Non-Urgent Crossing Status: Indicator Found UCIP Comments: unable to confirm if conduit or gas line cross levee or flag identifying problem areas. Need additional information. FIELD_STRUCT_DESC: Underground service alert (USA) markers found on waterside (WS) and landside (LS) during field inspection. FS Date: 12/20/2013

View of landward side.

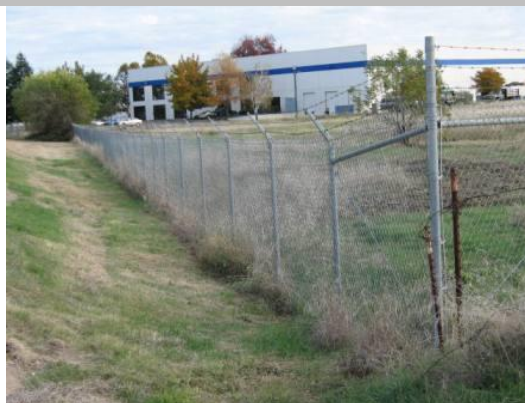
Photo 1 of 1 : SP_2016_NA0001_59_7_20160229_00005.jpg

LM Start	1.30	Rating **	M	Issue No.	7
LM End	1.33	Issue Type +	En	Location *	LS
Category	Earthen Levee			GPS Latitude/Longitude	
				Start	End
Item	Encroachments			38.661593 °	38.661370 °
				-121.431420 °	-121.430943 °
DWR ID	DWR_NA0001_08_s_2012_7				
Comment Code					
FE : Fence					
Inspector Comment					
Cyclone fence with barbed wire within 10' of toe for part of its alignment.

11/17/2011 Chainlink fence at levee toe.

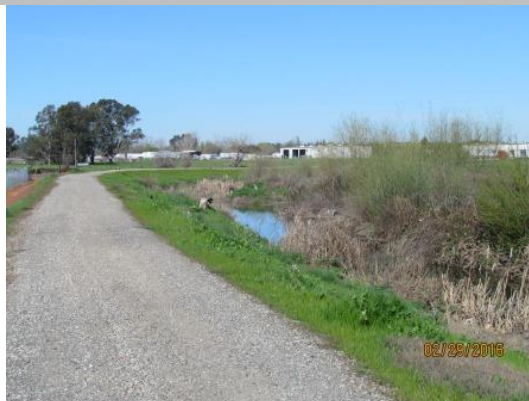
Photo 1 of 1 : SP_2016_NA0001_59_14_20160307_00015.jpg

LM Start	1.32	Rating **	M	Issue No.	14
LM End	1.39	Issue Type +	Ma	Location *	WS
Category	Earthen Levee			GPS Latitude/Longitude	
				Start	End
Item	Vegetation			38.661459 °	38.660995 °
				-121.431190 °	-121.430133 °
DWR ID	DWR_NA0001_08_s _ 2016_14				
Comment Code					
V1 : Control annual grass and weeds on the levee slopes and easements.					
Inspector Comment

View of the vegetation on the waterside levee slope, looking downstream.

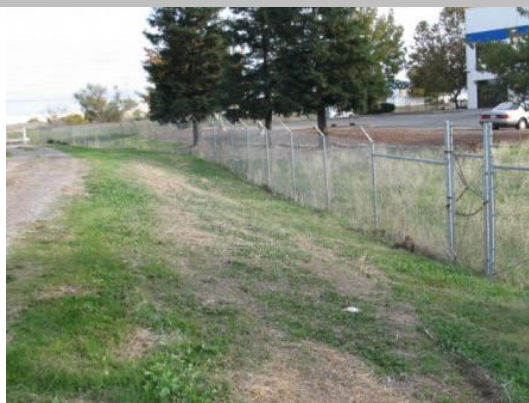
Photo 1 of 1 : SP_2016_NA0001_59_8_20160229_00006.jpg

LM Start	1.39	Rating **	M	Issue No.	8
LM End	1.43	Issue Type +	En	Location *	LS
Category	Earthen Levee			GPS Latitude/Longitude	
				Start	End
Item	Encroachments			38.660968 °	38.660828 °
				-121.430023 °	-121.429428 °
DWR ID	DWR_NA0001_08_s _ 2013_8				
Comment Code					
FE : Fence					
Inspector Comment					
Cyclone fence alignment returns to within 10' of toe.

11/17/2011 Chainlink fence alignment returns to the levee toe.

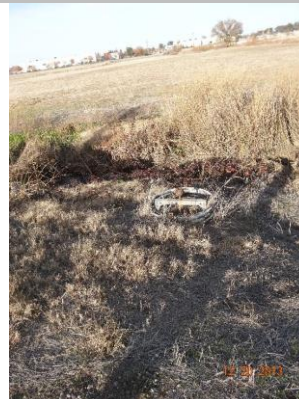
Photo 1 of 2 : UCIP_SP_2016_29329_54333.jpg

Comment Code					
Inspector Comment					
FS_ID:29329 DS_ID:24384 EP_NO: N/A Repair Type: Non-Urgent Crossing Status: Indicator Found UCIP Comments: Non-functional crossing--need to coordinate with owner, DWR-Inspector, and CVFPB to determine how to properly abandon crossing. FIELD_STRUCT_DESC: Abandoned 24-inch pipe through the levee, 8.0 feet below the crown. Two CM cutoff walls around pipe. Slide gate in 30-inch CM riser and flap gate at waterside (WS) end. Concrete "U" headwall and splash apron on WS end. Landside (LS) end cutoff and plugged, riser filled with dirt. (USACE-1959). This entry matches the Drainage or Irrigation Structure referenced in O&M manual (Station 72+10). FS Date: 12/20/2013

View of riser with slide gate located on waterward side.

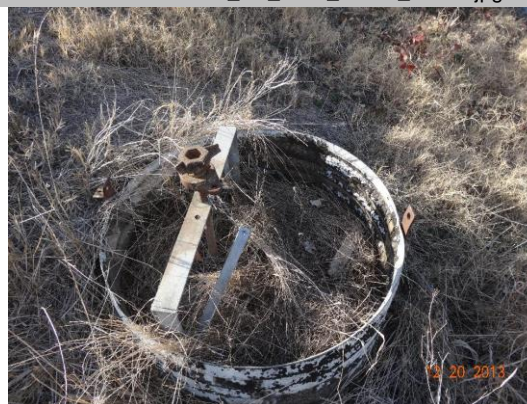
Photo 2 of 2 : UCIP_SP_2016_29329_54332.jpg

Slide gate non-functional--riser filled with soil.

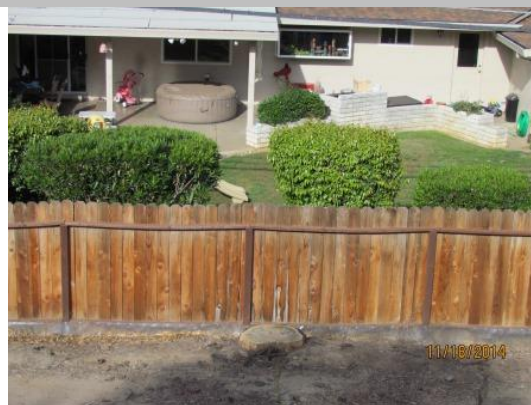
Photo 1 of 1 : SP_2016_NA0001_60_12_20160229_00003.jpg

LM Start	0.40	Rating **	N	Issue No.	12
LM End	0.40	Issue Type +	Ma	Location *	LS
Category	Earthen Levee			GPS Latitude/Longitude	
				Start	End
Item	Trim / Thin Trees			38.566725 °	38.566725 °
				-121.389935 °	-121.389935 °
DWR ID	DWR_NA0001_09_f_2013_12				
Comment Code					
T5 : Tree stumps.					
Inspector Comment

View of the tree stump at the landside levee toe.

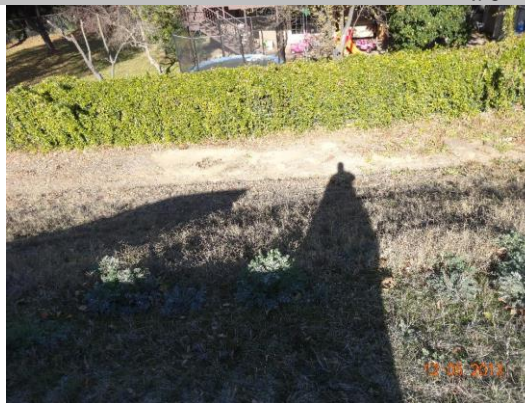
Photo 1 of 2 : UCIP_SP_2016_29347_54363.jpg

LM Start	1.29	Rating **	M	Issue No.	31
LM End	1.29	Issue Type +	En	Location *	LS
Category	Supplemental			GPS Latitude/Longitude	
				Start	End
Item	DWR UCIP Field Study			38.562285 °	38.562285 °
				-121.405265 °	-121.405265 °
DWR ID					
Comment Code					
Inspector Comment					
FS_ID:29347 DS_ID:24394 EP_NO: N/A Repair Type: Non-Urgent Crossing Status: Indicator Found UCIP Comments: Need to contact owner to determine status of crossing. FIELD_STRUCT_DESC: Abandoned 12-inch steel pipe through the levee, 14.0 feet below the crown. Riser unit on waterside (WS). (USACE-1959). This entry matches the Drainage or Irrigation Structure referenced in O&M manual (Station 296+85). Pipe abandonment was referenced in Permit No. 4622 (1964). FS Date: 12/5/2013

View of landward side.

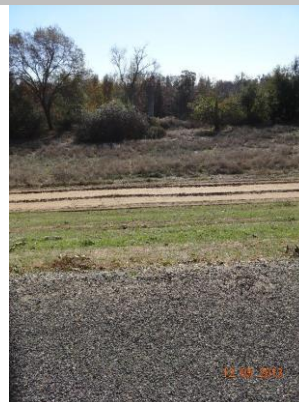
Photo 2 of 2 : UCIP_SP_2016_29347_54362.jpg

View of waterward side--tall riser located approximately 200 feet away.

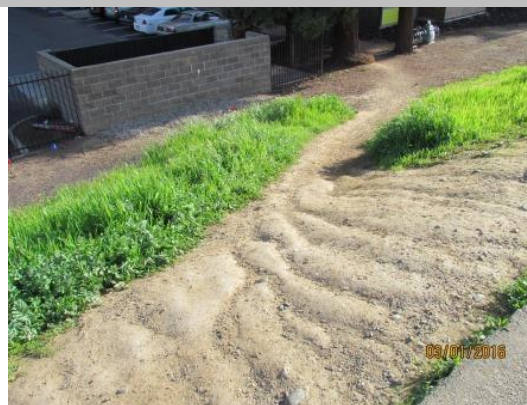
Photo 1 of 1 : SP_2016_NA0001_60_28_20160307_00042.jpg

View of the landside levee slope.

LM Start	1.88	Rating **	A/W	Issue No.	28
LM End	1.88	Issue Type +	Ma	Location *	LS
Category	Earthen Levee			GPS Latitude/Longitude	
				Start	End
Item	Slope Stability			38.561171 °	38.561171 °
				-121.415808 °	-121.415808 °
DWR ID	DWR_NA0001_09_s_2016_28				
Comment Code					
S2 : Repair the levee slope damaged by foot traffic and prevent access where possible.					
Inspector Comment

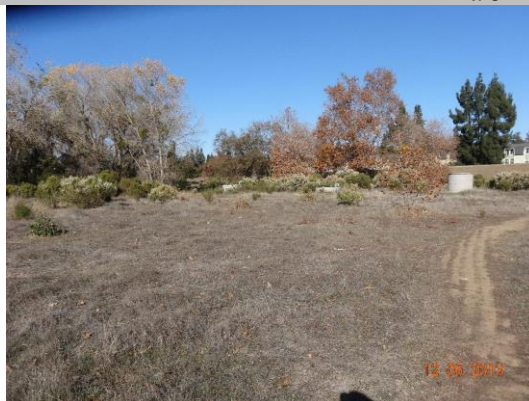
Photo 1 of 2 : UCIP_SP_2016_29351_54369.jpg

LM Start	1.93	Rating **	M	Issue No.	32
LM End	1.93	Issue Type +	En	Location *	LS
Category	Supplemental			GPS Latitude/Longitude	
				Start	End
Item	DWR UCIP Field Study			38.560889 °	38.560889 °
				-121.417196 °	-121.417196 °
DWR ID					
Comment Code					
Inspector Comment					
FS_ID:29351 DS_ID:24597 EP_NO: 17587 Repair Type: Non-Urgent Crossing Status: Indicator Found UCIP Comments: Unable to confirm if riser belongs to this crossing--need to coordinate with owner to determine specifics. Description needs to be updated. FIELD_STRUCT_DESC: 54-inch water main through the levee at unknown depth. (Permit No. 17587-2003) FS Date: 12/5/2013

Three risers located on waterward berm.

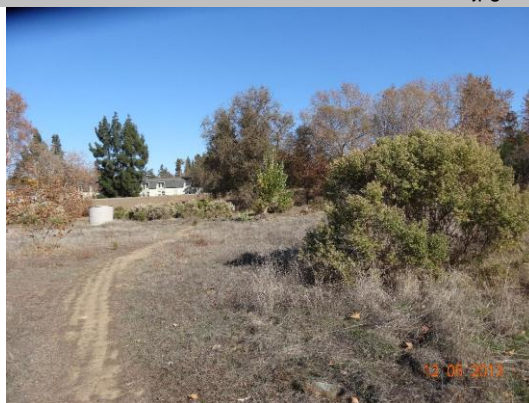
Photo 2 of 2 : UCIP_SP_2016_29351_54368.jpg

View of waterward berm looking toward levee crown from waterward berm edge.

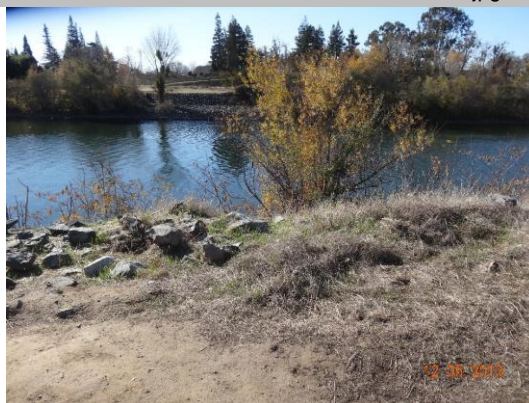
Photo 2 of 2 : UCIP_SP_2016_30124_55521.jpg

Rip rap used along waterward toe.

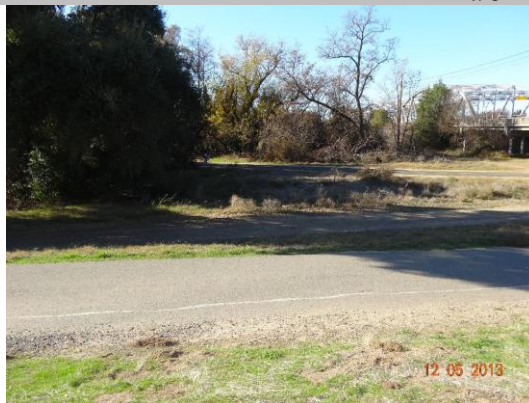
Photo 1 of 2 : UCIP_SP_2016_31309_57338.jpg

LM Start	2.51	Rating **	M	Issue No.	38
LM End	2.51	Issue Type +	En	Location *	LS
Category	Supplemental			GPS Latitude/Longitude	
				Start	End
Item	DWR UCIP Field Study			38.568767 °	38.568767 °
				-121.421178 °	-121.421178 °
DWR ID					
Comment Code					
Inspector Comment					
FS_ID:31309					
DS_ID:24515					
EP_NO: N/A					
Repair Type: Non-Urgent					
Crossing Status: Indicator Found					
UCIP Comments: Unable to confirm crossing. will need to contact owner to determine specifics and status of crossing.					
FIELD_STRUCT_DESC: 36-inch corrugated metal (CM) pipe through the levee. Riser unit on waterside (WS). (USACE-1959). This entry matches the Drainage or Irrigation Structure referenced in O&M manual (Station 365+14).					
FS Date: 12/5/2013

View of waterward side.

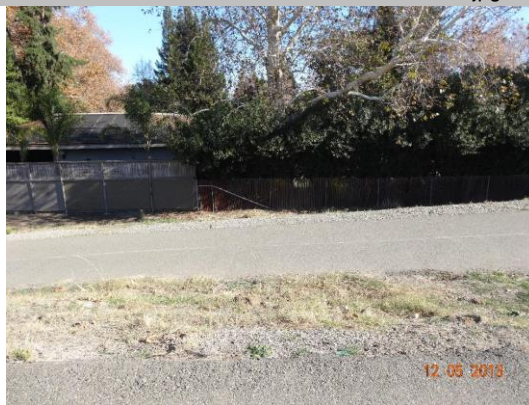
Photo 2 of 2 : UCIP_SP_2016_31309_57337.jpg

View of landward side.

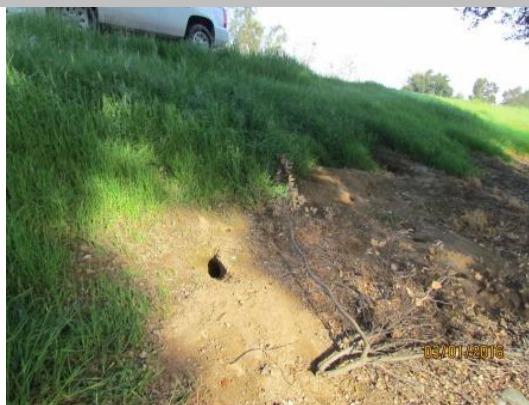
Photo 1 of 1 : SP_2016_NA0001_60_26_20160307_00041.jpg

View of the rodent holes in the landside levee slope.

LM Start	2.70	Rating **	M	Issue No.	26
LM End	2.70	Issue Type +	Ma	Location *	LS
Category	Earthen Levee			GPS Latitude/Longitude	
				Start	End
Item	Animal Control			38.571431 °	38.571431 °
				-121.420737 °	-121.420737 °
DWR ID	DWR_NA0001_09_s _ 2016_26				
Comment Code					
A1 : Exterminate rodents and backfill and compact or grout burrows.					
Inspector Comment

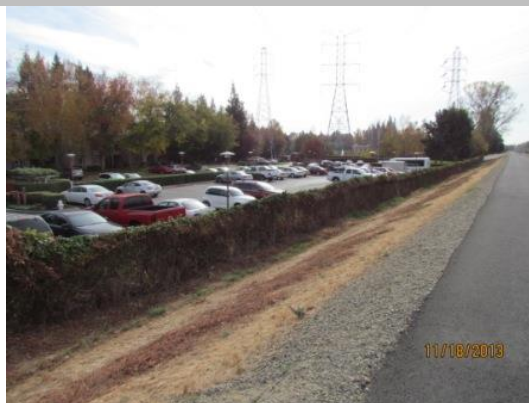
Photo 1 of 1 : SP_2016_NA0001_60_2_20160229_00002.jpg

LM Start	3.06	Rating **	U	Issue No.	2
LM End	3.19	Issue Type +	En	Location *	LS
Category	Earthen Levee			GPS Latitude/Longitude	
				Start	End
Item	Encroachments			38.576423 °	38.578248 °
				-121.419117 °	-121.418475 °
DWR ID	DWR_NA0001_09_s _ 2012_2				
Comment Code					
FE : Fence					
Inspector Comment

View of the trimmed vegetation on the chain linked fence still obstructing visibility.

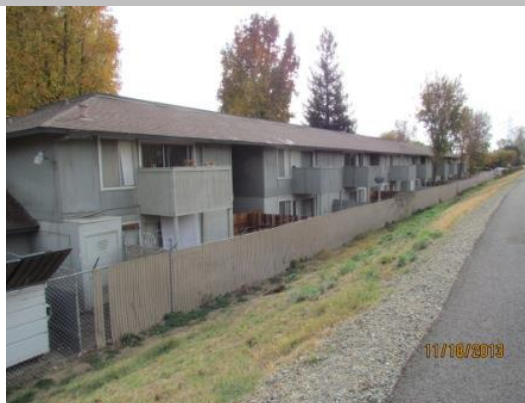
Photo 1 of 1 : SP_2016_NA0001_60_1_20160229_00001.jpg

LM Start	3.19	Rating **	U	Issue No.	1
LM End	3.27	Issue Type +	En	Location *	LS
Category	Earthen Levee			GPS Latitude/Longitude	
				Start	End
Item	Encroachments			38.578258 °	38.579363 °
				-121.418475 °	-121.418100 °
DWR ID	DWR_NA0001_09_s_2012_1				
Comment Code					
FE : Fence					
Inspector Comment

View of the fence at the landside levee toe.

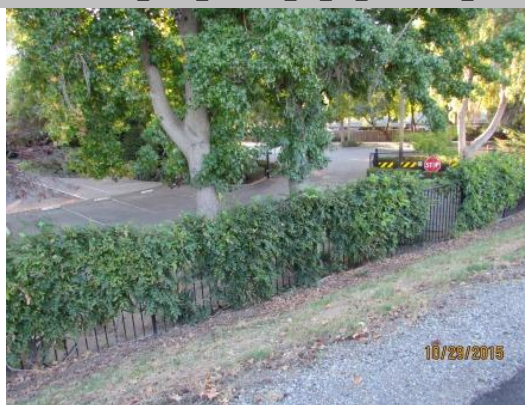
Photo 1 of 1 : SP_2016_NA0001_60_24_20160229_00006.jpg

LM Start	3.30	Rating **	M	Issue No.	24
LM End	3.30	Issue Type +	En	Location *	LS
Category	Earthen Levee			GPS Latitude/Longitude	
				Start	End
Item	Vegetation			38.579851 °	38.579851 °
				-121.417896 °	-121.417896 °
DWR ID	DWR_NA0001_09_f_2015_24				
Comment Code					
V6 : Landscaping					
Inspector Comment					
Vine on the LS fence blocking visibility.

View of the vines on the fence at the landside levee toe.

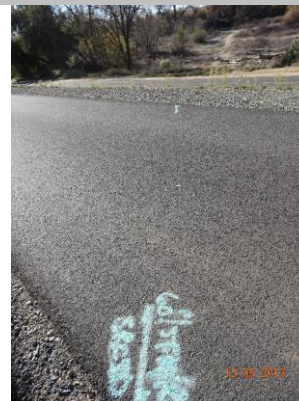
Photo 1 of 2 : UCIP_SP_2016_30125_55526.jpg

FS_ID:30125
DS_ID:24412
EP_NO: 17671
Repair Type: Non-Urgent
Crossing Status: Indicator Found
UCIP Comments: unable to confirm if manhole is part of this crossing--
need to contact owner to determine status of crossing.
FIELD_STRUCT_DESC: 1 of 2: 60-inch sewer main under the levee.
Connects to 60-inch main on landside (LS). (Permit No. 17671-2003)
FS Date: 12/5/2013

View of waterward side.

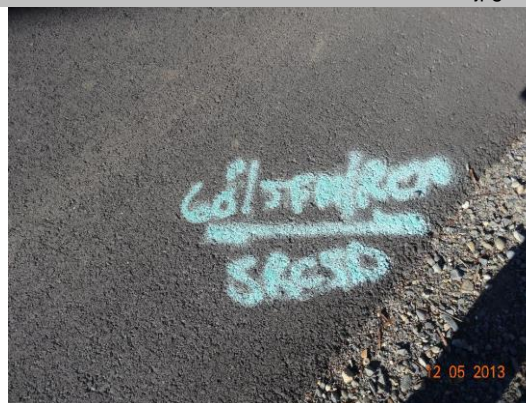
Photo 2 of 2 : UCIP_SP_2016_30125_55528.jpg

Underground service alert (USA) paint found on bike path on waterward side.

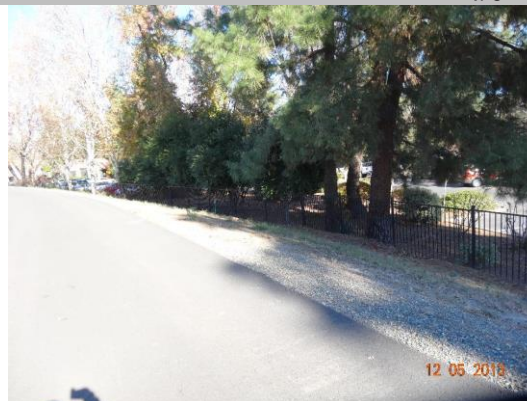
Photo 1 of 2 : UCIP_SP_2016_29633_54791.jpg

LM Start	3.34	Rating **	M	Issue No.	33
LM End	3.34	Issue Type +	En	Location *	LS
Category	Supplemental			GPS Latitude/Longitude	
				Start	End
Item	DWR UCIP Field Study			38.580347 °	38.580347 °
				-121.417734 °	-121.417734 °
DWR ID					
Comment Code					
Inspector Comment					
FS_ID:29633 DS_ID:24404 EP_NO: 12188 Repair Type: Non-Urgent Crossing Status: Indicator Found UCIP Comments: unable to confirm if crossing is still active--need to contact owner to determine status of crossing. FIELD_STRUCT_DESC: 60-inch concrete encased steel sewer line through the levee, 17.0 feet below the crown. Cutoff wall around pipe at the center of the levee. Rock revetment on waterside (WS) slope. Three pressure manholes in overflow area along pipe path. (Permit No. 12188-1979) FS Date: 12/5/2013

View of landward side.

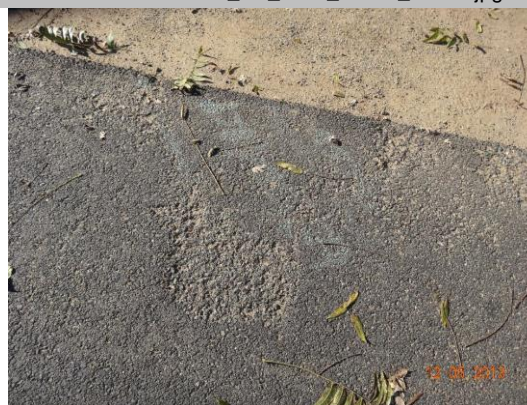
Photo 2 of 2 : UCIP_SP_2016_29633_54790.jpg

Underground service alert (USA) markings still present on levee crown.

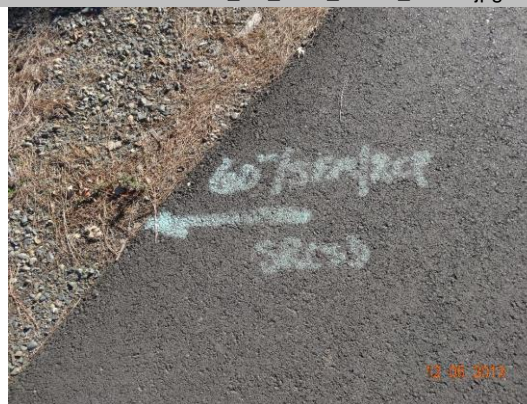
Photo 2 of 2 : UCIP_SP_2016_41437_55531.jpg

LM Start	3.34	Rating **	M	Issue No.	41
LM End	3.34	Issue Type +	En	Location *	LS
Category	Supplemental			GPS Latitude/Longitude	
				Start	End
Item	DWR UCIP Field Study			38.580435 °	38.580435 °
				-121.417711 °	-121.417711 °
DWR ID					
Comment Code					
Inspector Comment					
FS_ID:41437 DS_ID:24566 EP_NO: 17671 Repair Type: Non-Urgent Crossing Status: Indicator Found UCIP Comments: Need to confirm location with owner. FIELD_STRUCT_DESC: 2 of 2: 60-inch sewer main under the levee. Connects to 60-inch main on landside (LS). (Permit No. 17671-2003) FS Date: 12/5/2013

Underground service alert (USA) markings found on levee crown for 60-inch pipe.

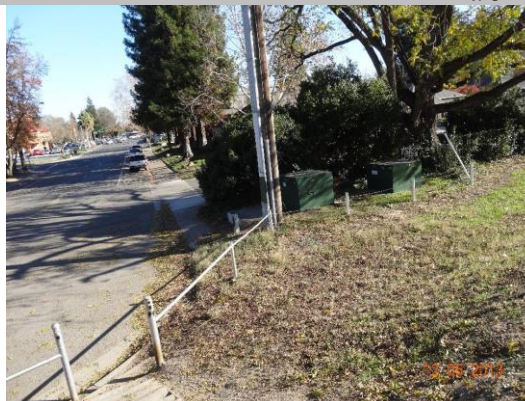
Photo 1 of 2 : UCIP_SP_2016_30684_56473.jpg

LM Start	3.42	Rating **	M	Issue No.	39
LM End	3.42	Issue Type +	En	Location *	LS
Category	Supplemental			GPS Latitude/Longitude	
				Start	End
Item	DWR UCIP Field Study			38.581572 °	38.581572 °
				-121.417819 °	-121.417819 °
DWR ID					
Comment Code					
Inspector Comment					
FS_ID:30684 DS_ID:24816 EP_NO: N/A Repair Type: Non-Urgent Crossing Status: Indicator Found UCIP Comments: unable to determine if crossing goes through levee. Need to obtain additional information to confirm crossing. FIELD_STRUCT_DESC: Water fountain found on waterside (WS). FS Date: 12/5/2013

View of landward side.

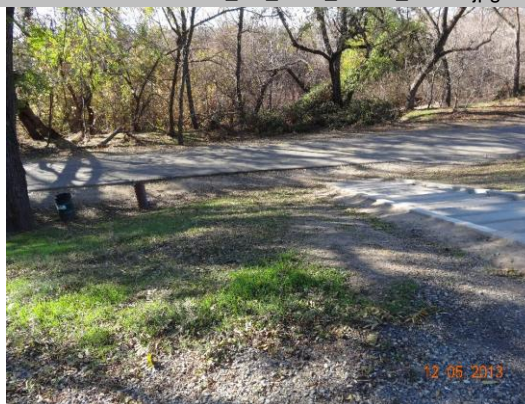
Photo 2 of 2 : UCIP_SP_2016_30684_56472.jpg

View of waterward side.

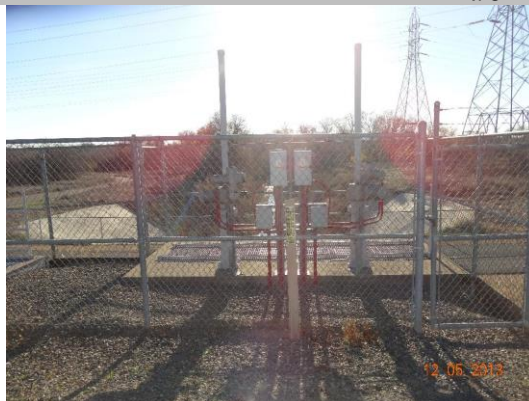
Photo 1 of 2 : UCIP_SP_2016_31304_57325.jpg

LM Start	3.68	Rating **	M	Issue No.	40
LM End	3.68	Issue Type +	En	Location *	LS
Category	Supplemental			GPS Latitude/Longitude	
				Start	End
Item	DWR UCIP Field Study			38.584344 °	38.584344 °
				-121.420968 °	-121.420968 °
DWR ID					
Comment Code					
Inspector Comment					
FS_ID:31304 DS_ID:24817 EP_NO: N/A Repair Type: Non-Urgent Crossing Status: Found UCIP Comments: Need to confirm crossing size--need additional information about crossing. FIELD_STRUCT_DESC: 1 of 2: Crossing through levee at unknown depth. Concrete structure (7x15-foot) located on waterside (WS) shoulder with slide gate inside manhole. Square flap gate located on WS end. Concrete wings and apron at WS end of outlet channel. Concrete box located on the WS shoulder fenced off. FS Date: 12/5/2013

Concrete box and electrical box located on waterward shoulder.

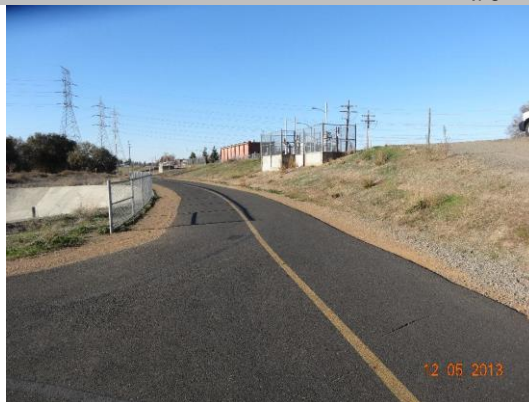
Photo 2 of 2 : UCIP_SP_2016_31306_57328.jpg

Bike path located on waterward side.

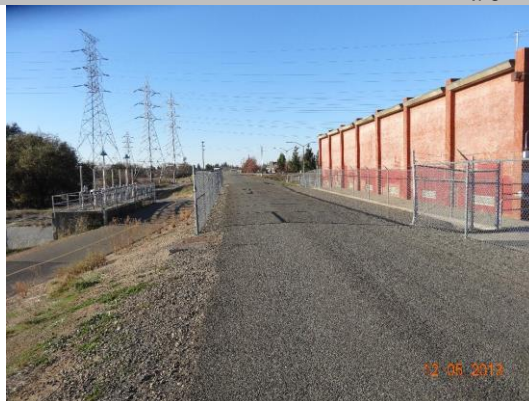
Photo 1 of 2 : UCIP_SP_2016_31307_57335.jpg

LM Start	3.72	Rating **	M	Issue No.	37
LM End	3.72	Issue Type +	En	Location *	LS
Category	Supplemental			GPS Latitude/Longitude	
				Start	End
Item	DWR UCIP Field Study			38.584710 °	38.584710 °
				-121.421496 °	-121.421496 °
DWR ID					
Comment Code					
Inspector Comment					
FS_ID:31307 DS_ID:24819 EP_NO: N/A Repair Type: Non-Urgent Crossing Status: Found UCIP Comments: Unable to confirm is pipe crosses levee--no permit available. FIELD_STRUCT_DESC: Service box located on waterside (WS) and landside (LS). Unable to confirm crossing exists through levee. No permit found for this potential crossing. FS Date: 12/5/2013

View of concrete service box located on waterward shoulder.

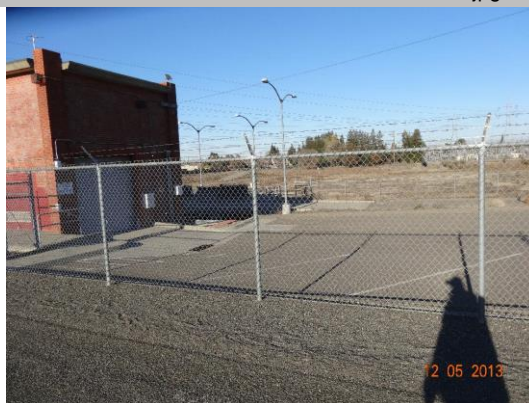
Photo 2 of 2 : UCIP_SP_2016_31307_57334.jpg

Concrete box located inside fenced area located on landward side.

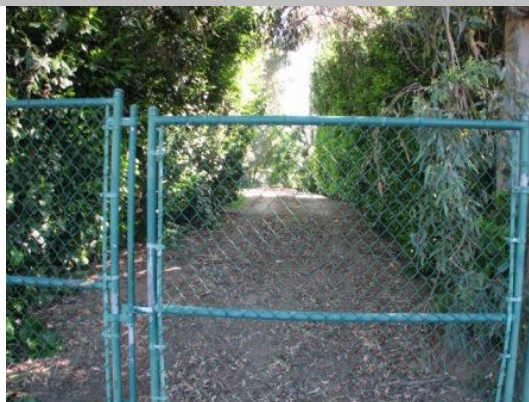
Photo 1 of 1 : SP_2016_NA0001_61_16_20160229_00004.jpg

LM Start	0.00	Rating **	U	Issue No.	16
LM End	0.62	Issue Type +	En	Location *	CR
Category	Earthen Levee			GPS Latitude/Longitude	
				Start	End
Item	Encroachments			38.600917 °	38.592184 °
				-121.332100 °	-121.334347 °
DWR ID	DWR_NA0001_10_s_2012_16				
Comment Code					
UR : Urban					
Inspector Comment

Levee encroached on by property owners north of Arden Way. This section is not reasonably accessible.

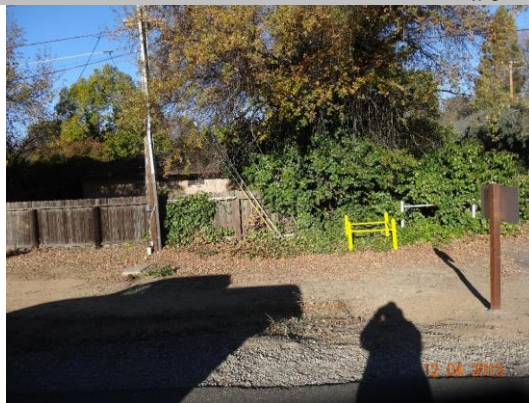
Photo 1 of 2 : UCIP_SP_2016_31450_57501.jpg

LM Start	0.62	Rating **	M	Issue No.	122
LM End	0.62	Issue Type +	En	Location *	CR
Category	Supplemental			GPS Latitude/Longitude	
				Start	End
Item	DWR UCIP Field Study			38.592105 °	38.592105 °
				-121.334423 °	-121.334423 °
DWR ID					
Comment Code					
Inspector Comment					
FS_ID:31450 DS_ID:24820 EP_NO: N/A Repair Type: Non-Urgent Crossing Status: Indicator Found UCIP Comments: Unable to determine alignment of crossing, does it cross levee? Permit? FIELD_STRUCT_DESC: Protective posts located on landside (LS) for what appears to be for gas/petroleum line. Unable to confirm if line goes through levee or if line runs parallel. No permit found. FS Date: 12/4/2013

View of protective posts located on landward side.

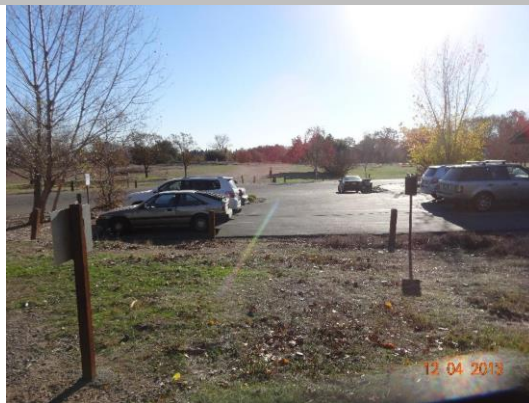
Photo 2 of 2 : UCIP_SP_2016_31450_57500.jpg

No signs of crossing on waterward side.
